## 4. Cleaning

### The problems and the cleaning decisions

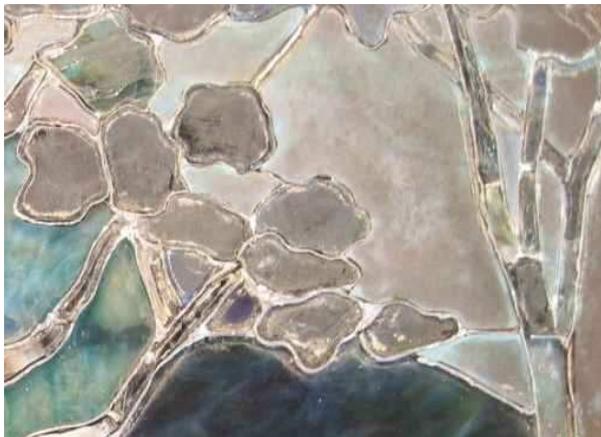
A dark opaque film covered the exterior side of the window.

Mr. Brill's advise to get rid of this dark opaque film is to use some lye (Hydroxide sodium), diluted at 10 %. The lye is harmless for the glass. The brand used is "Red Devil". The pieces of glass except for the painted ones are soaked in a solution of 90 % of warm water and 10 % of lye for half an hour. The water is kept warm with a heating element. Then, they are brushed very softly with a nylon brush to get rid of the dark film, (the use of an organic brush is not recommended because the lye will destroy it), and rinsed carefully under water.

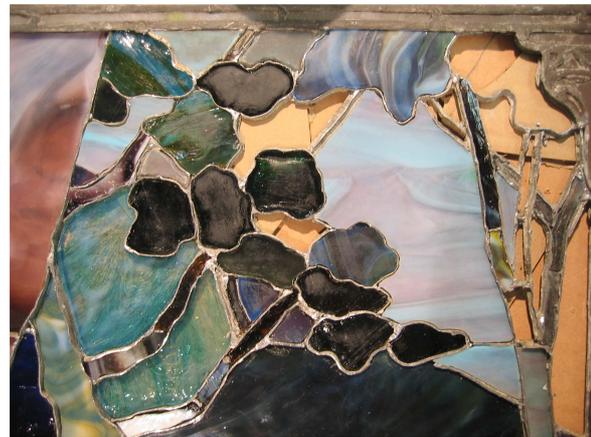
The pieces after cleaning.

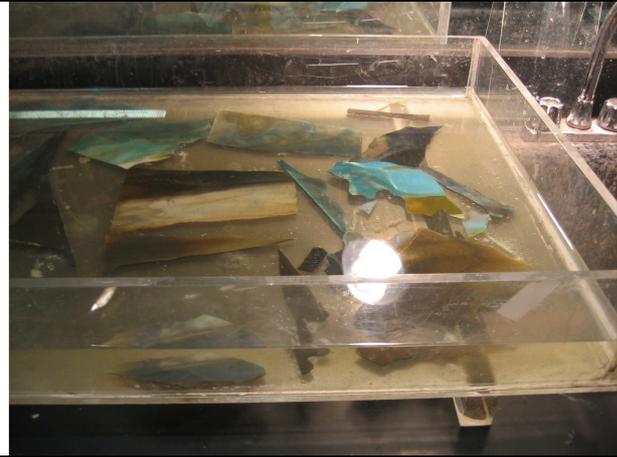
The pieces are being soaked in a solution of 10% lye and 90% of warm water for half an hour.

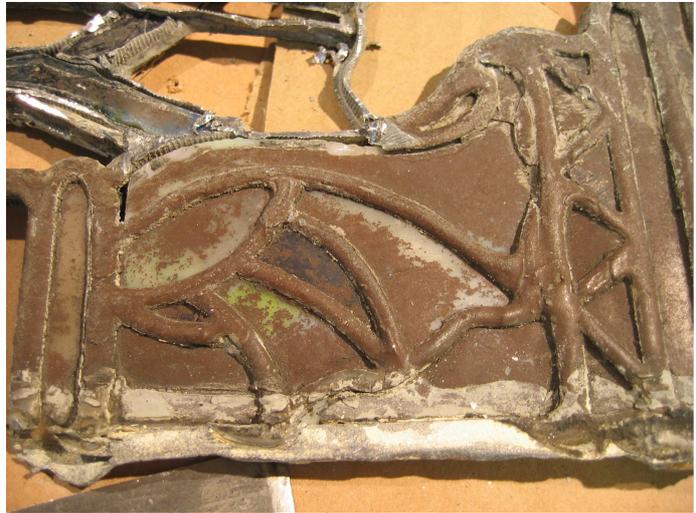
All the edges of the panels are covered with a layer of brown oil paint which has been sprayed with paint spay when repainting the wood frame.

To remove the brown paint, a detergent made of cellulose “Safest Stripper” (3M / Dimethyl adipate, Dimethyl glutarate), harmless for the glass, is very convenient because it can be laid on the glass as a gel. The pieces are soaked half an hour and then rinsed under water.

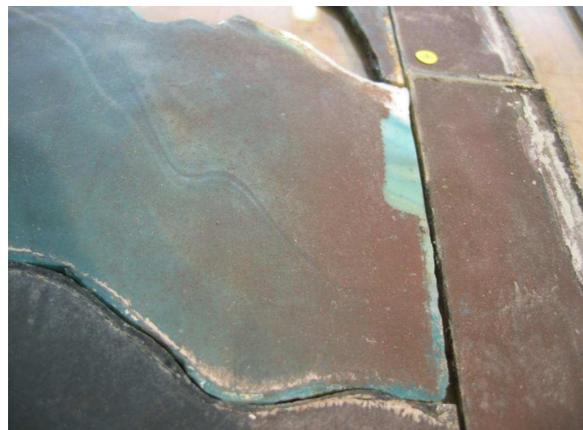
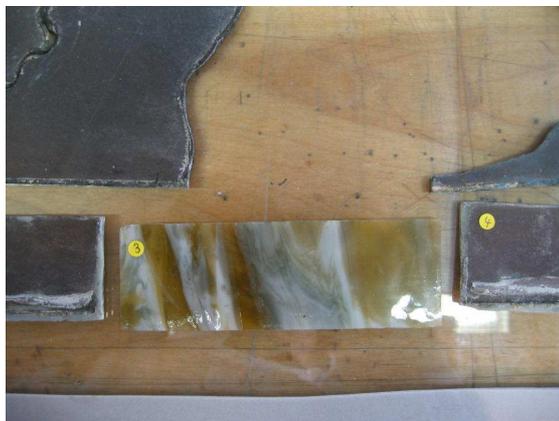
There is a large amount of soot between the layers of glass which could have come from a fire across the street from the church and/or the burning of candles inside the church.

To get rid of the soot, the pieces of glass are soaked for 1 hour in a solution of 75 % warm water and 25 % of “Simple Green”, an organic detergent, very effective in removing the dirt.

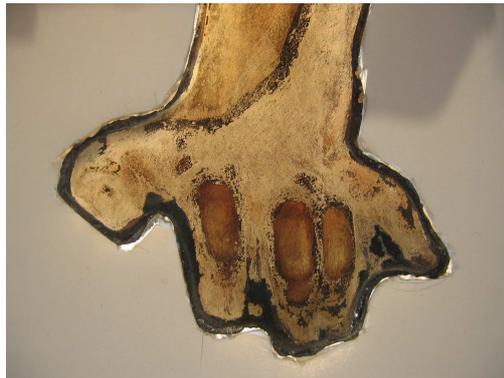
The painted surfaces have deteriorated over time. There is a severe loss of paint. There is a big amount of soot on the painted pieces too.

Because the paint is so fragile, the soot will be cleaned only using water with cue-tips. The cue-tip will be rolled very softly on the areas to clean without scrubbing at all.

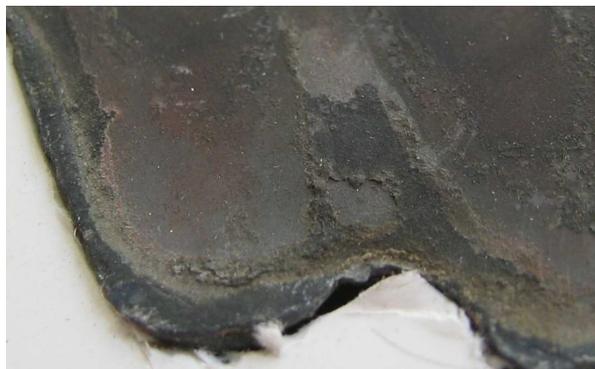
Some areas of paint have turned into a thick dark crust which is very unstable.

There is nothing to be done in this case and the crusted areas ought to be touched as little as possible.

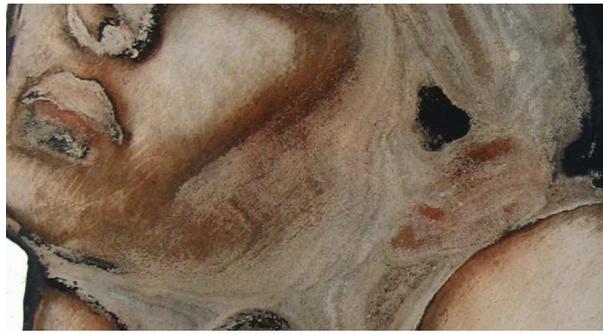
An exact replica of the panel, in better condition with regards to the painted pieces, has been discovered in the Brown Baptist Memorial Church. All the areas that are crusted in Lafayette Avenue Presbyterian Church, are areas where there are some enamels laid on “grisaille”. It seems as though the presence of enamels allows this process. It is also possible that miscalculations in the firing caused the problem.

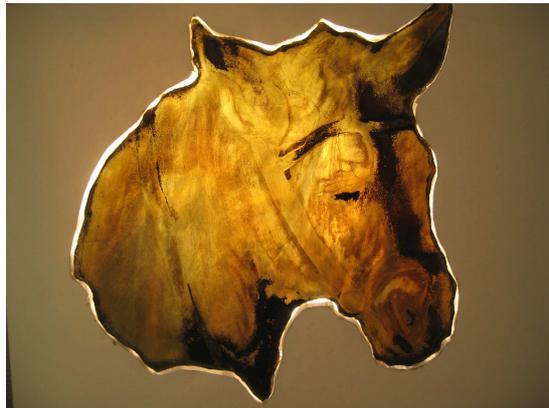
The exterior side of the painted pieces is also covered with the dark opaque film making the painted pieces less legible.

The pieces must be cleaned with some lye. But they cannot be soaked with the other pieces.

The borders of the pieces are covered with sticky foam and they are laid on little bases made of foam. This will avoid the lye dripping on the opposite side. The pieces of glass must never be moved or touched during this process.

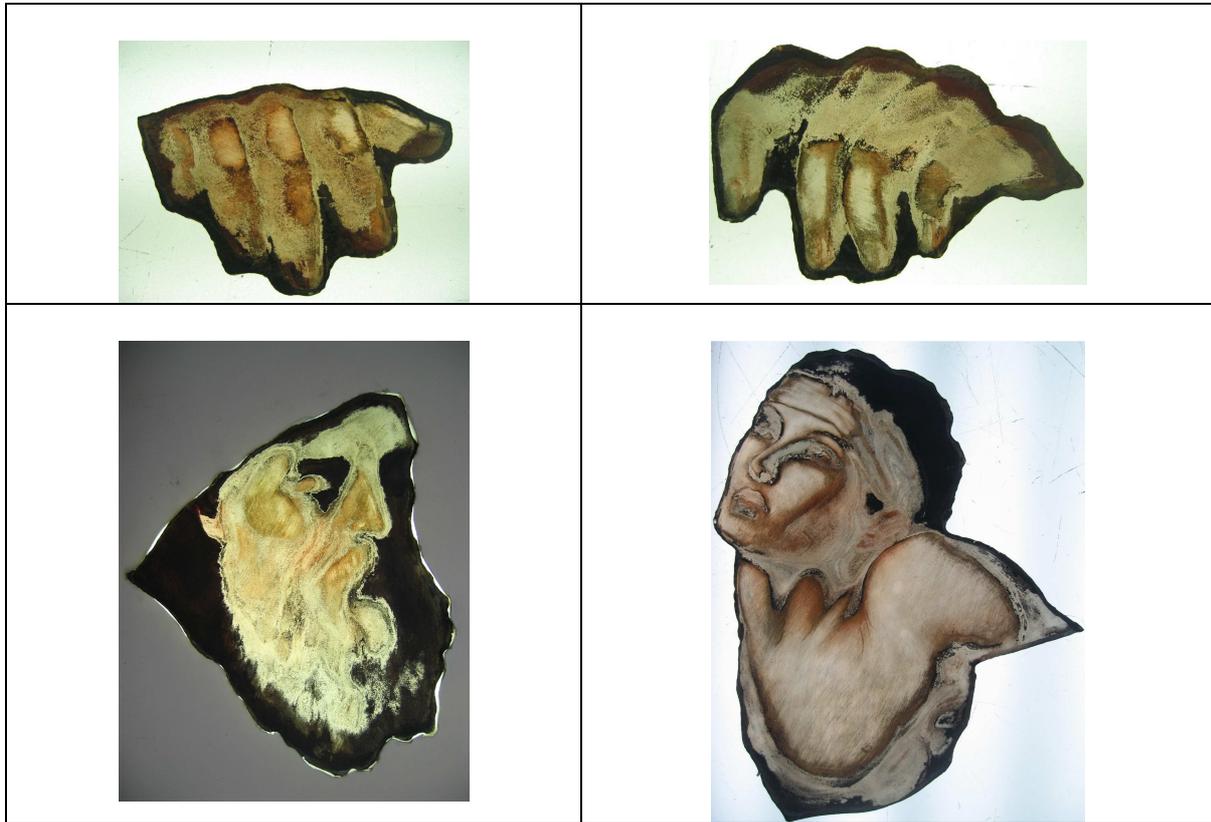
The painted pieces are in a very bad condition and they are all in need of restoration. The paint loss is severe, leaving many pieces almost illegible to the eye. The deterioration of the paint is due to several reasons:

- The painters used a variety of mediums which were not always compatible. In our case, the grisailles seem to have deteriorated because of a layer of enamel fired on top of them. According to Arthur J. Femenella<sup>1</sup>, “Enamels are fired at lower temperatures and usually adhere to themselves better than they do to the glass. If the coefficients of expansion between the glass and the enamel differ significantly, they may become unstable and may peel off the glass in sheets. This may also occur on a smaller scale with trace and matte paints. The loss of enamel is common to Tiffany windows.”

- The glass seems to have been insufficiently fired. Temperature controls seem to have been inaccurate and the glass has been under-fired making the paint unstable.
- Also, the protective glazing installed seems to have been an aggravating factor in the deterioration of the painted pieces. The window in Brown Baptist Memorial Church does not have a protective glazing and is in a much better condition; there is almost no paint loss. In fact, this would acknowledge the thesis that the protective glazing installed at the Lafayette Avenue Presbyterian Church did increase the deterioration of the stained glass windows.

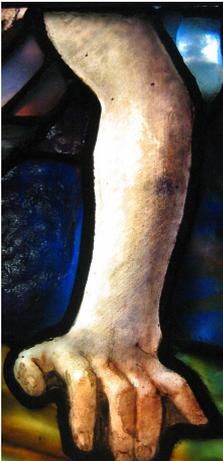
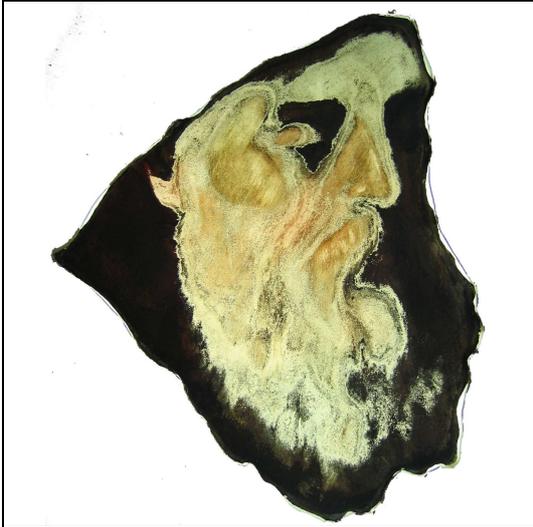
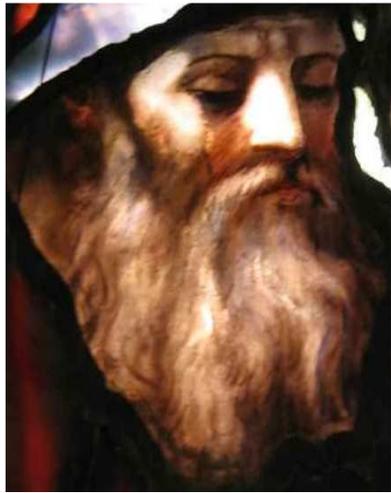
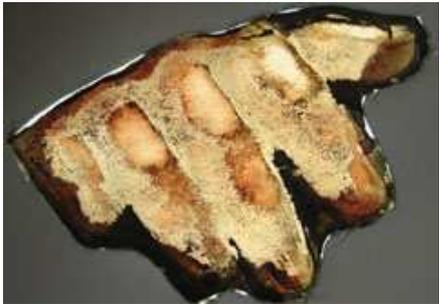
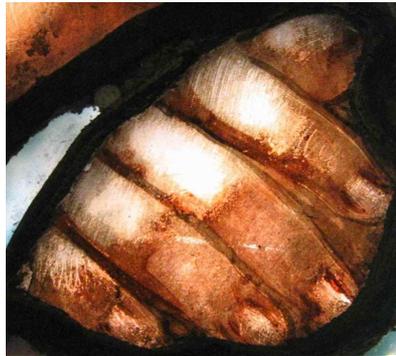
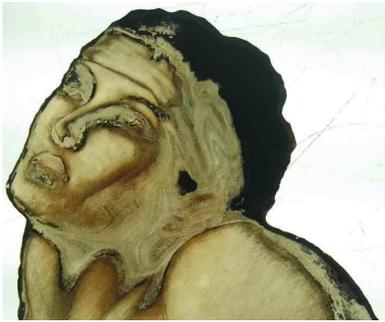
Lafayette Avenue Presbyterian Church	Brown Memorial Baptist Church

Numerous painted details being lost, research was done to try to help with the restoration process. Fortunately, as a similar panel has been found in Brown Memorial Baptist Church, elements of the flesh parts are a great help to determine exactly what has been lost.
